Optical and Biodynamic Evaluation of the Helmet Integrated Display Sight System (HIDSS) for the RAH-66 Comanche Development and Validation Program Phase

March 1998

U.S. Army Aeromedical Research Laboratory Fort Rucker, Alabama 36362-0577

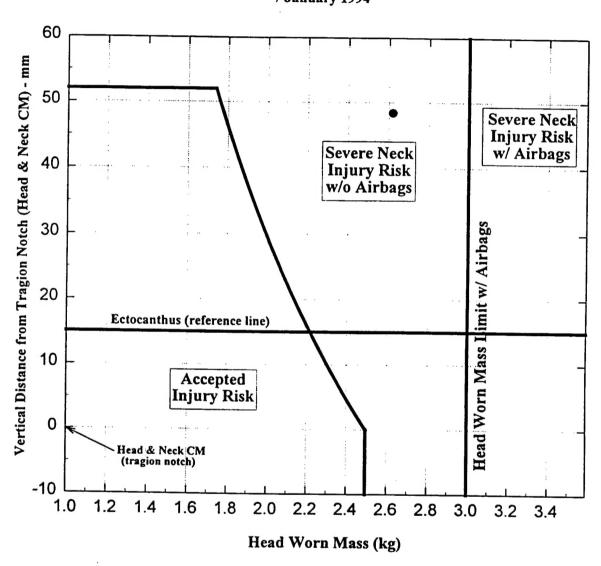
Figure 3. HIDSS mass/center of mass chart, z-axis.

The head supported mass and x- and z- axes relationships are illustrated in Figures 3 and 4 with the respective requirements. Figure 3 shows the measured mass and z-axis center of mass location to lie outside the accepted injury risk area of the constant moment curve (McEntire and Shanahan, 1996). If airbag restraint systems are used in the cockpit, these values are acceptable. Interpretation of this data point indicates the RAH-66 aircrew will be exposed to greater risk of sustaining a severe neck injury during helicopter mishaps than other Army aircrew.

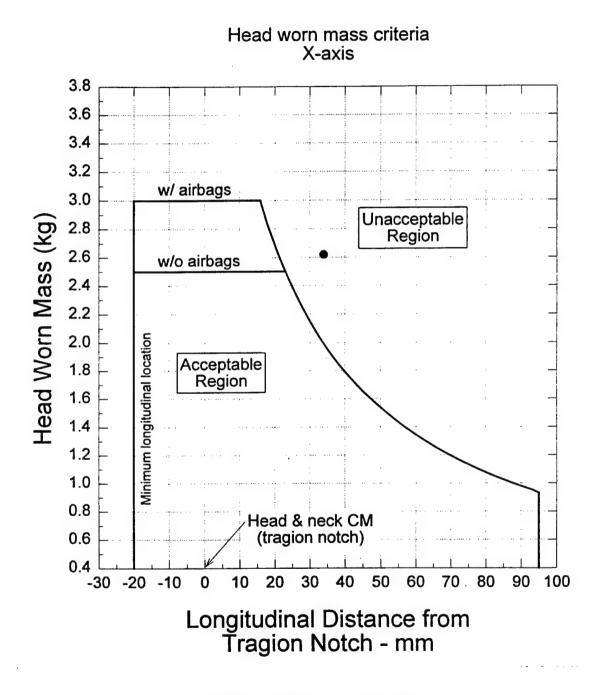
Figure 4. HIDSS mass/center of mass chart, x-axis.

Figure 4 shows the measured mass and z-axis CM location to lie also outside the acceptable region. This constant moment curve is based on significant changes in biodynamic response when exposed to helicopter vibration environments. The effects of prolonged or repeated exposures to these conditions are currently unknown, but it is possible that chronic pain and degenerative disorders may develop.

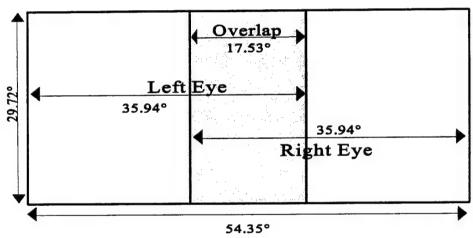
Figure 8. Monocular FOVs with overlap.

Results. See Figure 8. The overlap region measured 17.53° horizontally.

Impact. The measured overlap is within approximately 0.5° of the 17° design specification.

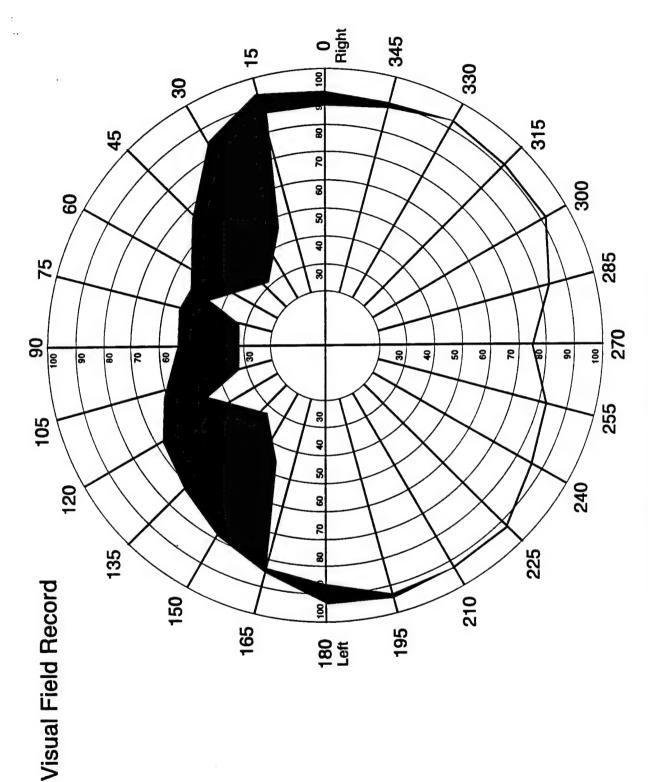
Figure 9. Binocular visual field for the PRU only.

Results. Figures 9-11 show the measured visual fields. Figure 9 shows the available binocular visual field when only the HIDSS PRU is being worn. Figures 10 and 11 show monocular visual fields for the left and right eyes when the ARU with baffles is attached.

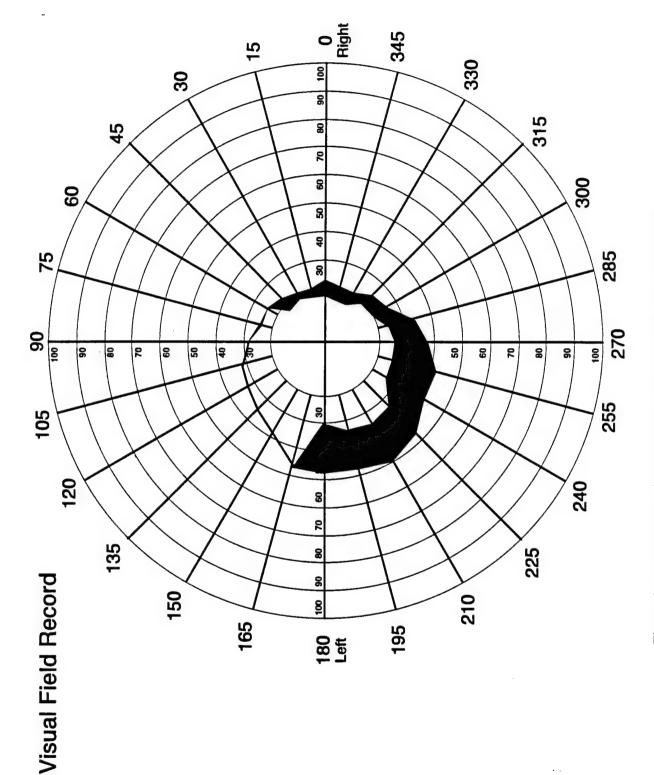
Impact. The fields showing the obscurations due to the baffles are not absolute. The fields will change as a function of eye position. It was determined that the vertical limits of the HIDSS are similar to that measured for the HGU-56/P helmet. Look-under capability is judged better than what is available for ANVIS. Since visual fields were measured monocularly, and while binocular blind spots may exist, the plots seem to indicate the presence of only minimal binocular blind spots. The existence of blind spots, however, will likely be deemed an annoyance to aviators.

Figure 10. Monocular visual field for left eye with ARU and baffle.

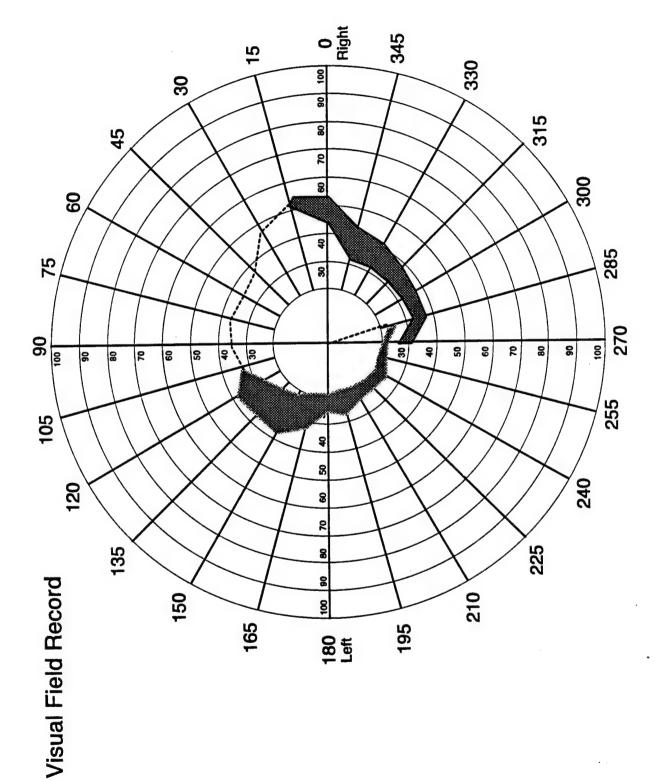
Figure 11. Monocular visual field for right eye with ARU and baffle. (Note: This visual field is slightly disjointed due to a shift in the helmet position during measurement.)

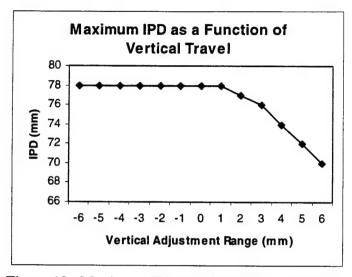
Figure 12. Maximum IPD as a function of vertical travel.

Results. We measured a 68-mm IPD with the IPD adjustment knobs set to the middle mark ("0" mark). The IPD could be adjusted over a ± 10 mm range (58 to 78 mm). The height adjustment had a ± 5 mm range. With the optics raised to their highest extent, the IPD was reduced due to interference from the ARU. The largest available IPD was reduced by 8 mm to 70 mm. Figure 12 shows the plot of the maximum available IPD as a function of the vertical adjustment.

Impact. Head anthropometry affects fit. Fit affects the positioning of the eyes into the exit pupils and therefore FOV. Based on the measurements above and the aviator population, the effective IPD range is limited to a maximum of 70 mm. Based upon anthropometric data (Gordan et al., 1989), a 70-mm IPD corresponds to the 98th percentile female and 90th percentile male.

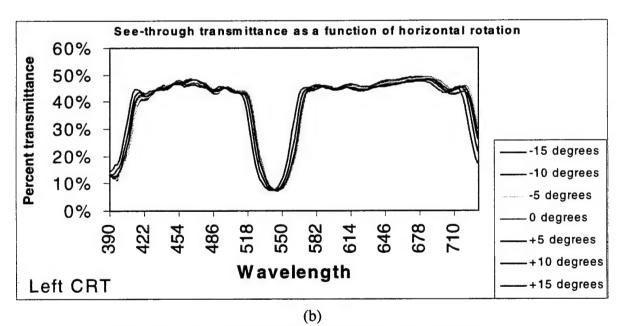
Figure 14. See-through spectral transmittance as a function of (a) horizontal and (b) vertical rotation.

these nominal values, we can also estimate the see-through transmittance of the main peak of the P-53 phosphor. Given a nominal 20% and 50% transmittance for the two lens, we can estimate a see-through transmittance of only 10%. Compare this estimate to the spectral transmittance curves shown in Figure 14. We see an approximate 10% transmittance average for the wavelengths around 544 nm. We mathematically calculated the transmittance for the P-53 peak to be 11.2%. Based upon these data, we feel our nominal estimates of system characteristics are close.

Results. The see-through spectral transmittance curves for a number of horizontal and vertical angular orientations are shown in Figure 14. Note the notch at 544 nm, the peak of the P53 CRT

image source phosphor. No significant angular effects were observed in the data. Transmittance on either side of the notch approaches 50%. Transmittance falls-off appreciably above 700 nm and below 420 nm. The average spectral transmittance across the measured spectral band (390 to 730 nm) is 40%. The see-through transmittance of a P53 phosphor display is estimated to be approximately 11%.

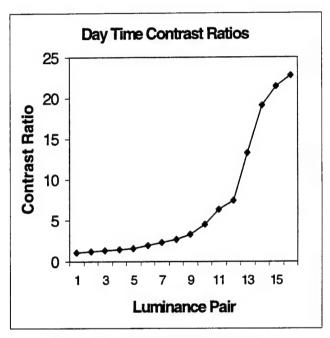
Figure 15. Contrast ratios, daytime.

Impact. By setting the background to a gray level of 15 (50 fL daytime and 1.4 fL night time), the resulting background had a decided effect upon the contrast ratios. The light from the background raised the light level of the dim half of the bipartite field, thereby lowering the contrast ratios. If we examine the line spread function data, we find that the peak of the luminance profile is approximately 400 times higher than the surrounding periphery (approximately 0.4 degrees from the illuminated line). The line spread data were collected under conditions where only the single line was illuminated. However, the contrast ratios were calculated based upon typical viewing conditions where small area contrast targets must be

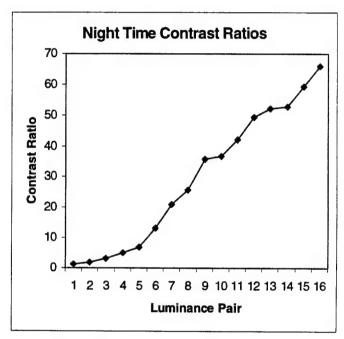
Figure 16. Contrast ratios, nighttime.

for nighttime conditions. The number of square-root-of-two shades of gray for the contrast ratio values of 22 and 66 are 9.9 and 13, respectively. This is verified when the available contrast ratio and shades of gray are theoretically calculated for the viewing conditions of 5000 fL ambient, 70% canopy transmittance, and 18% shaded visor transmittance and a CRT luminance of 3,300 fL. The resulting contrast ratio is 2.5 which correlates with 3.6 shades of gray.

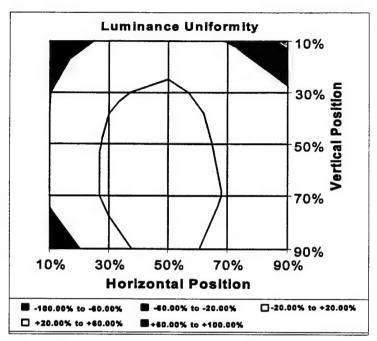
Results. Figure 17 shows a luminance uniformity plot expressed in ±20% bands. The bands show deviation from the mean luminance. The maximum deviation from the mean was 69%. This occurred at the lower right corner of the image. The deviation for most of the image area was less than 40%. In the FOV periphery, significant luminance fall-offs were observed.

Figure 17. Plot of luminance uniformity with $\pm 20\%$ bands.

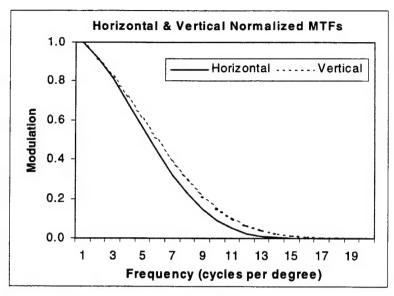
Results. The normalized horizontal and vertical MTFs are shown in Figure 18. As expected, the vertical MTF is slightly higher than the horizontal MTF over spatial frequencies beyond 3 cycles/degree (c/deg). The MTFs have fallen to 50% at only 6 to 7 cycles per degree and are 90% down at only 10 to 11 cycles per degree.

Impact. The MTFs appear to be low given the spatial bandwidth of the visual system. We noticed that the lines appeared out of focus and this could account for part of the low spatial resolution.

Figure 18. Normalized static MTFs for the horizontal and vertical meridians.

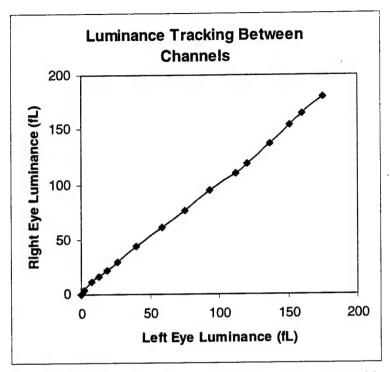
Figure 19. Left and right channel luminance tracking with ganged controls.

Results. Luminance tracking results can be seen in Figure 19. As can be seen from the figure, the luminance tracking was highly linear.

Impact. A highly linear luminance tracking will allow aviators to adjust overall luminance without introducing left and right channel luminance disparity.
